ROAD PAVEMENT FORENSICS

GPR for subsurface road conditions

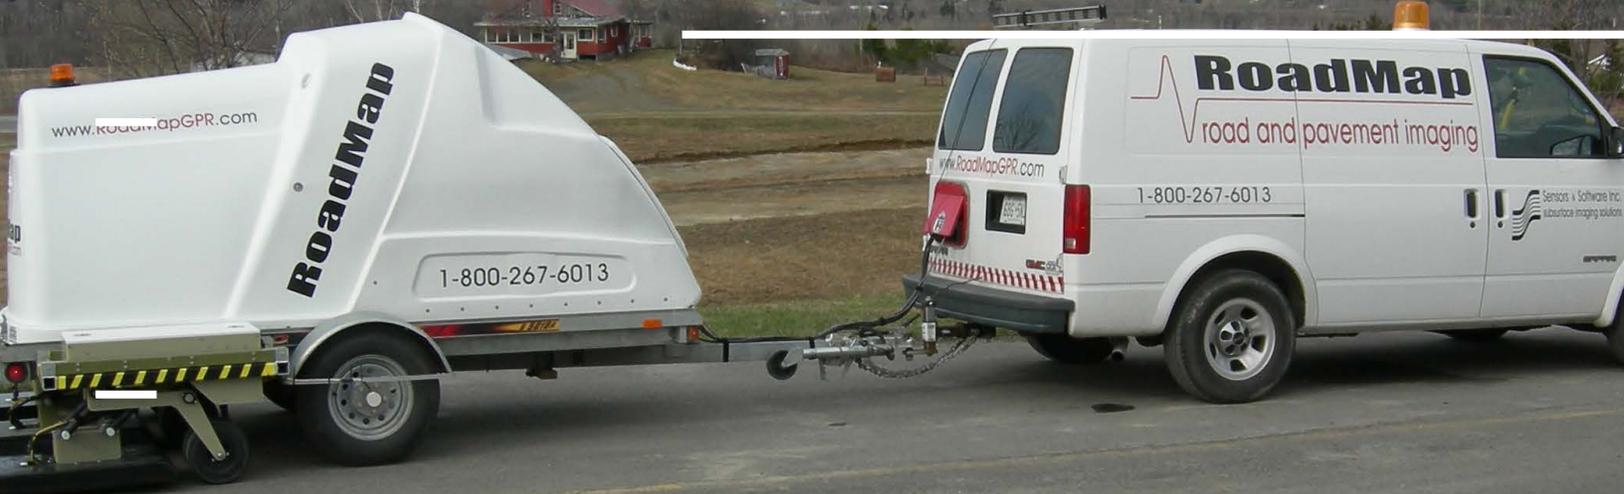
This custom Noggin configuration is capable of carrying multiple GPR sensors in a ground couple fashion at highway speeds on a legally-licensed platform.

RoadMap uses Noggin GPR systems to acquire precisely, geo-referenced GPR. Data are collected concurrently from multiple GPR sensors with differing frequencies and/or different path alignments. Synchronized video augments the GPR data, and all data are digitally recorded for later review and analysis.

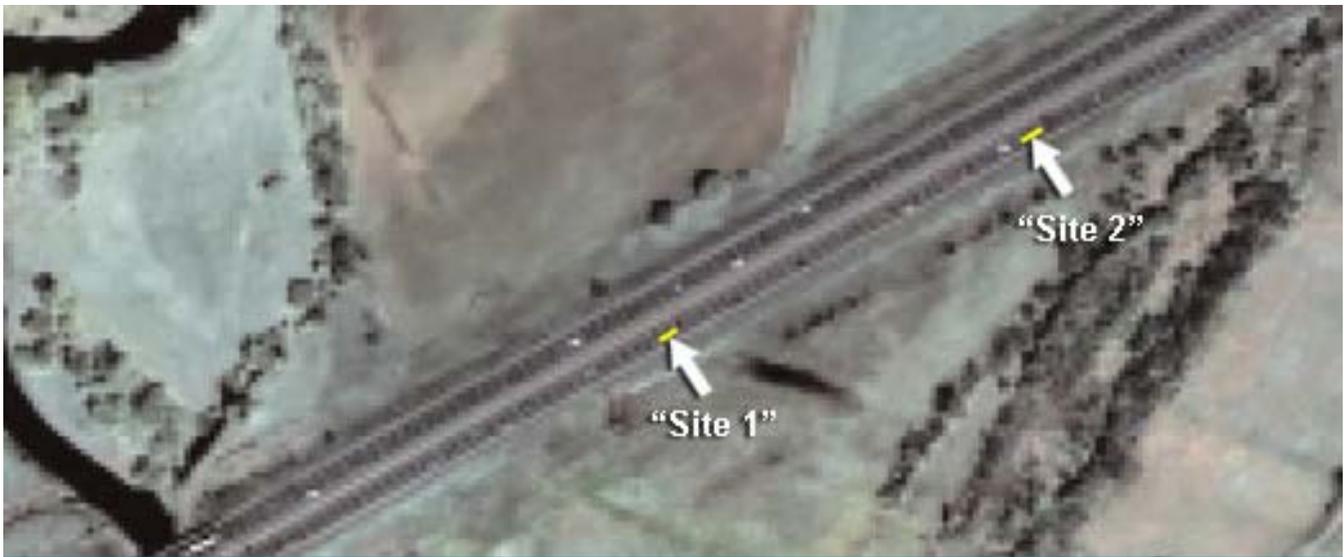
Surveys for undocumented and non-visible repair zones were conducted on Highway 401 in Toronto, Canada to plan maintenance and road upgrades. The highway in this area is 40 years old and has seen many upgrades and repairs. Two sites of surface degradation are marked on the Google Earth map, below.

The location of sites mapped with the RoadMap system

The road construction in the area consists of a 200 to 250 mm layer of asphalt pavement overlying concrete slab which in turn overlies granular material. Multiple passes over several lanes over a distance of about 14 km indentified numerous zones of past repairs and structural issues which were neither on record nor visible from the surface.

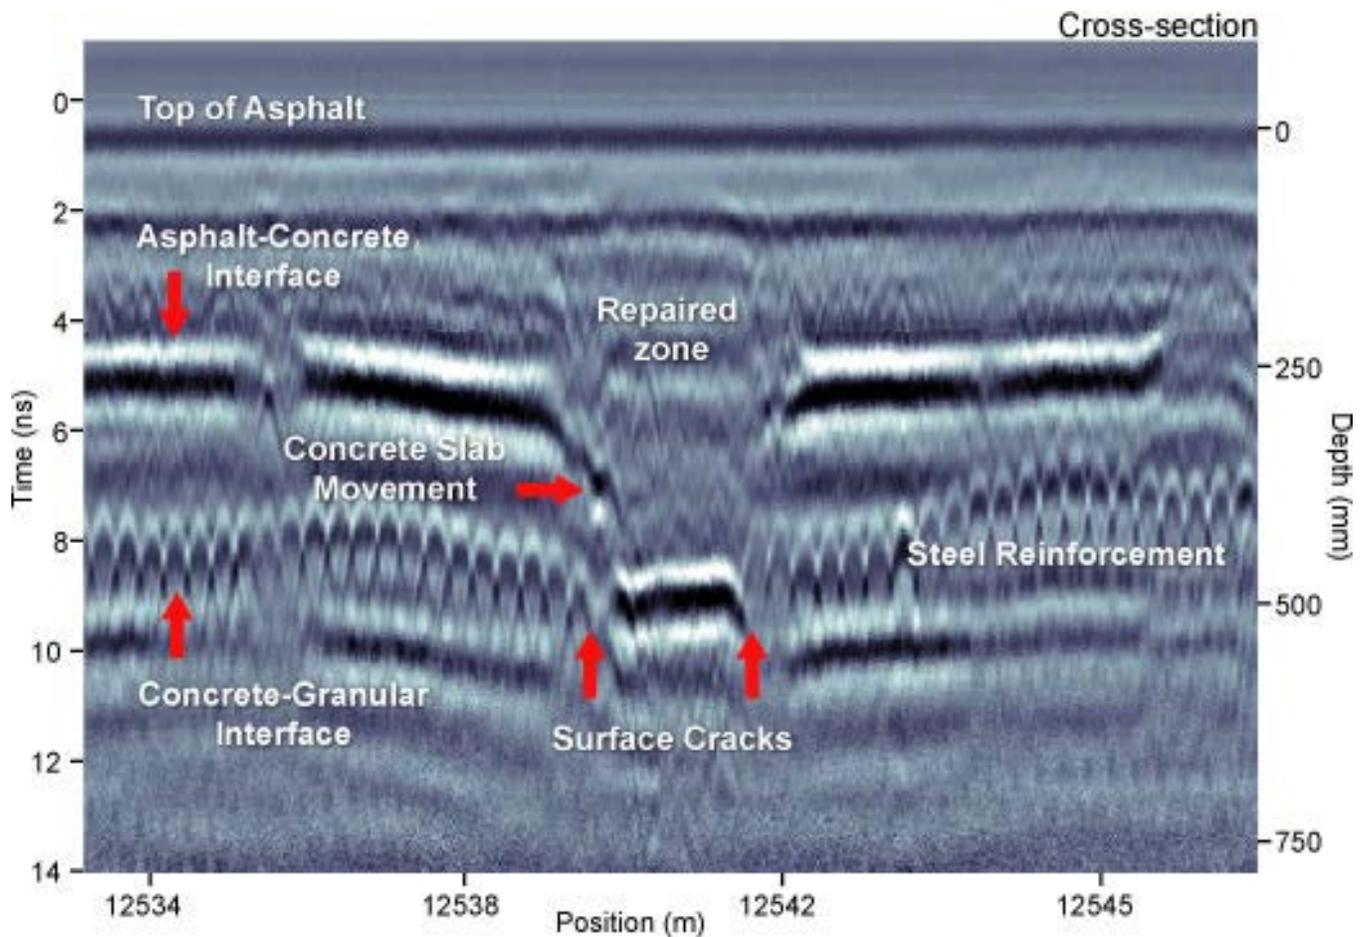
At “Site 1” a previous repair and tilting concrete slab to the left of the repair are clearly visible in this GPR section. Visible surface cracks bracket the repair.

“Site 1” shows a prior repair zone where part of the entire concrete slab has been removed. The concrete slab to the immediate left is also tilted.

In both instances, the RoadMap data were acquired at 0.01 m step size. Depths were determined from the localized point scattering diffractions and validated against subsequent core sampling.

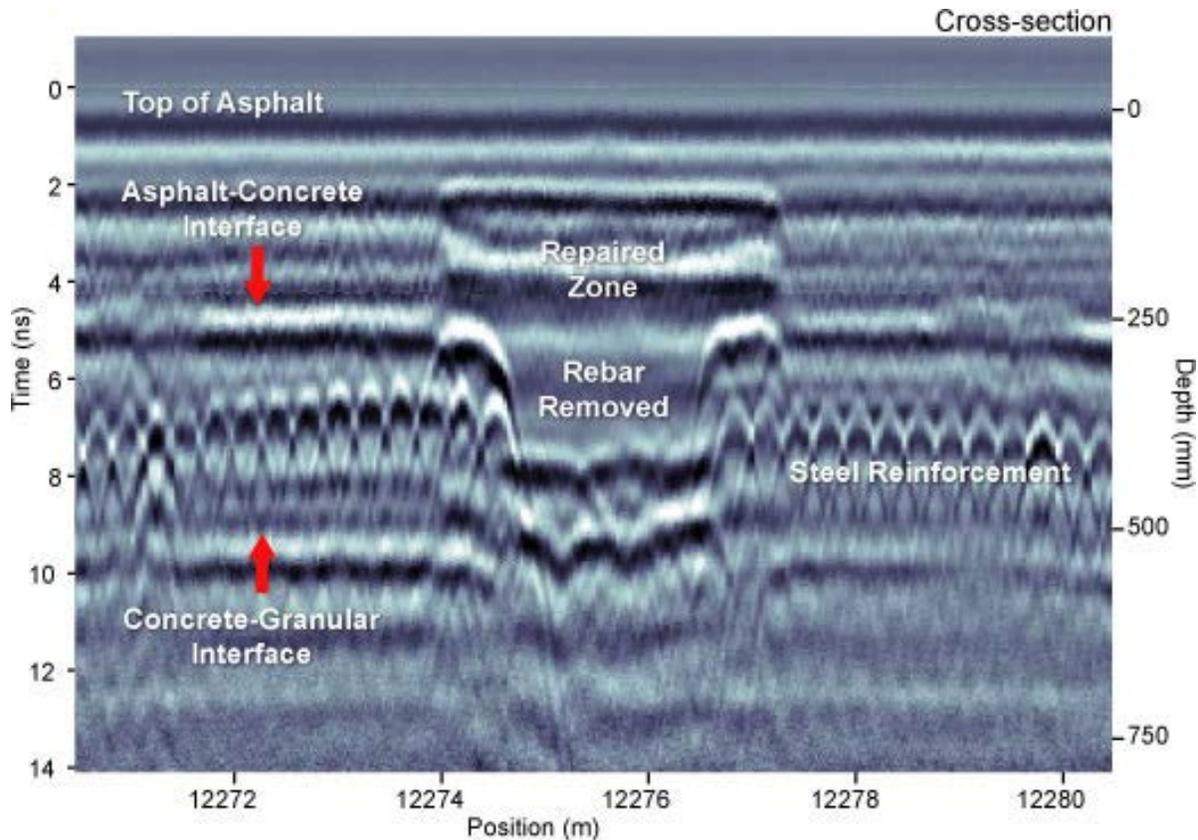
Another repair zone on Hwy. 401 - "Site 2". In the repaired section, the steel reinforcing and possibly the concrete slab have been removed.

“Site 2” indicates a different construction repair character. There were no clear surface expressions of the repair at the time of the survey.
